Your Inspection Report

Sample Report
My Village, CA

INSPECTION DATE:
Saturday, March 29, 2025

RE: Report No. 1002, v.0
Sample Report
My Village, CA

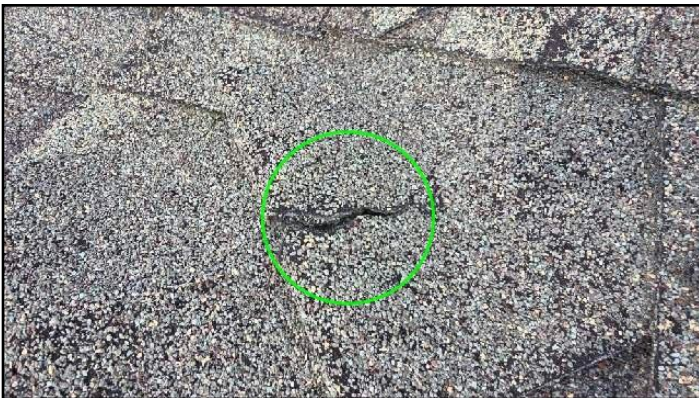
9. Cracked hip shingle

Task: Corrective service recommended | Review repair or replacement estimates by a qualified trade professional

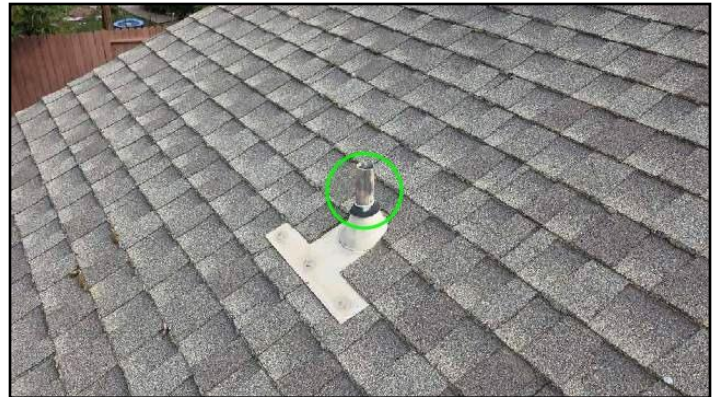
12. Cracked rubber boot collar

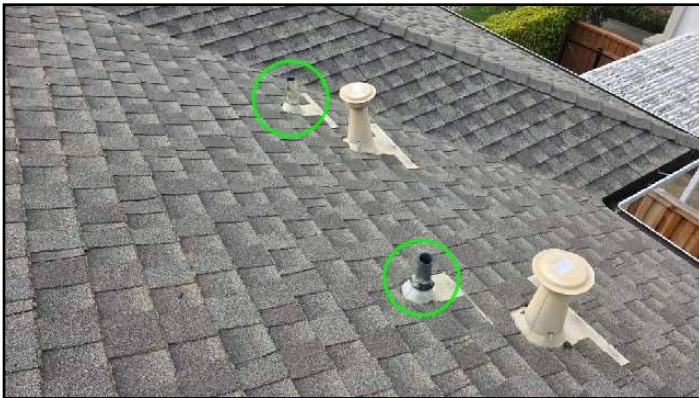
13. Cracked rubber boot collars

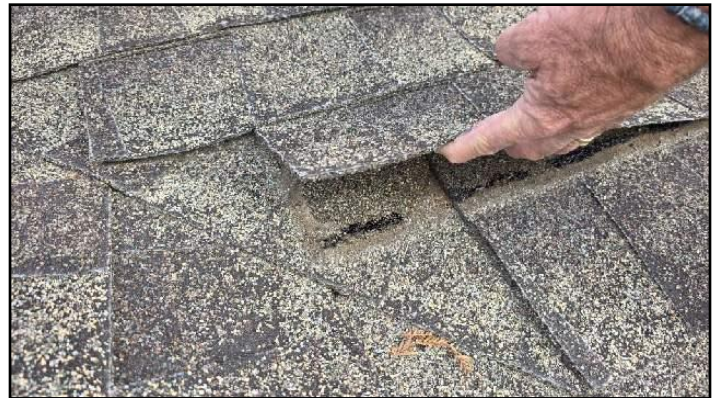
14. Loose valley shingles

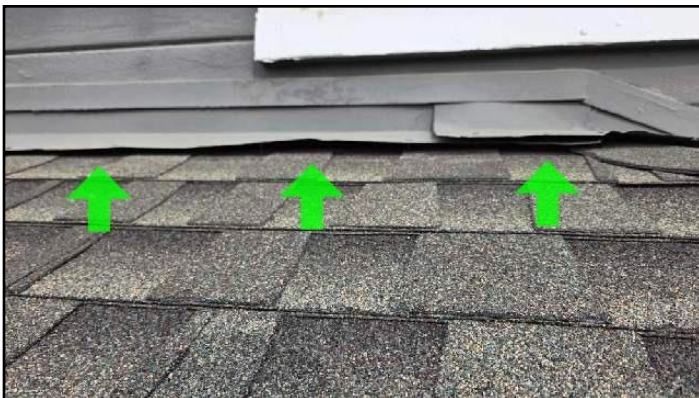
15. Lifted roof to wall flashing detail

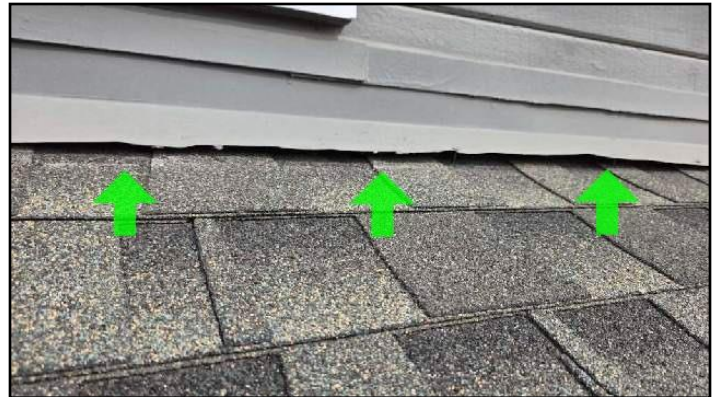
18. Lifted roof to wall flashing detail

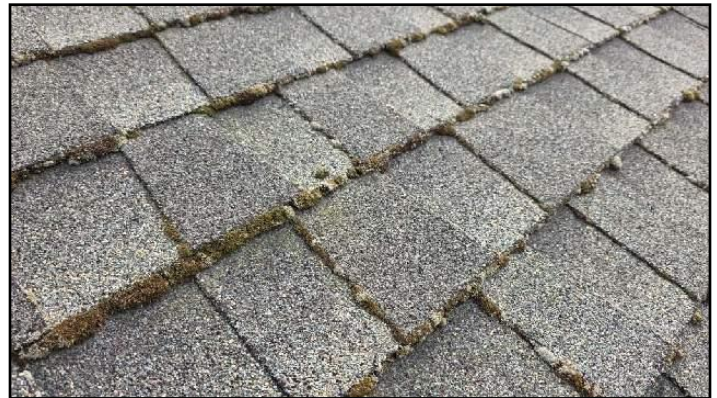
20. Moss growth

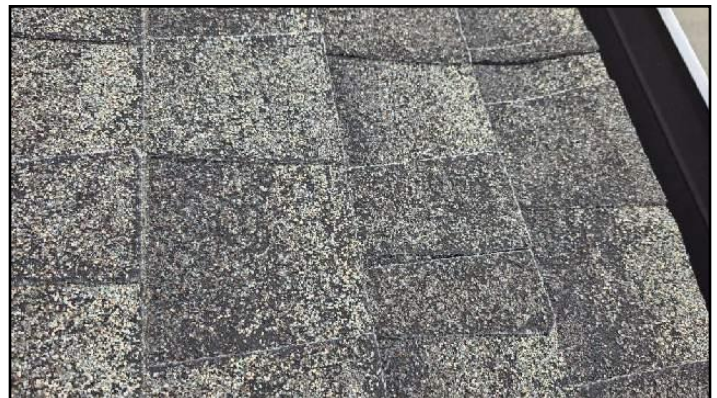
22. Granule loss

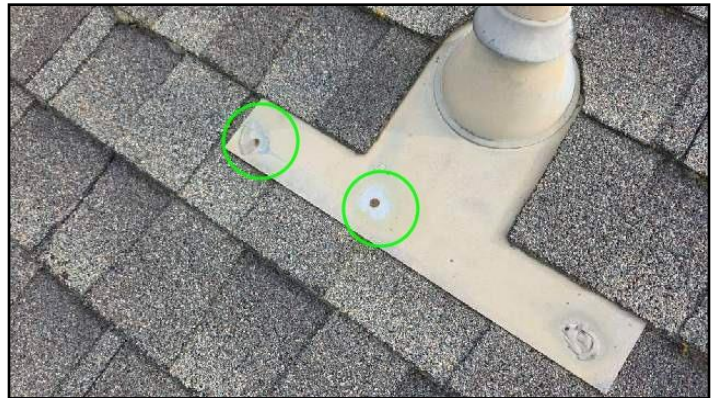
26. Exposed / unsealed fasteners

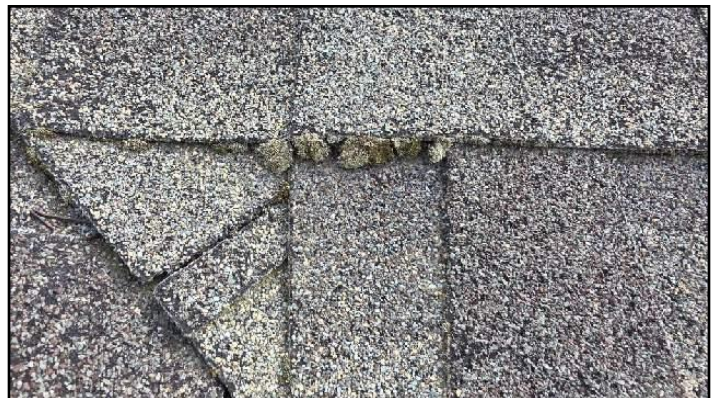
28. Moss growth

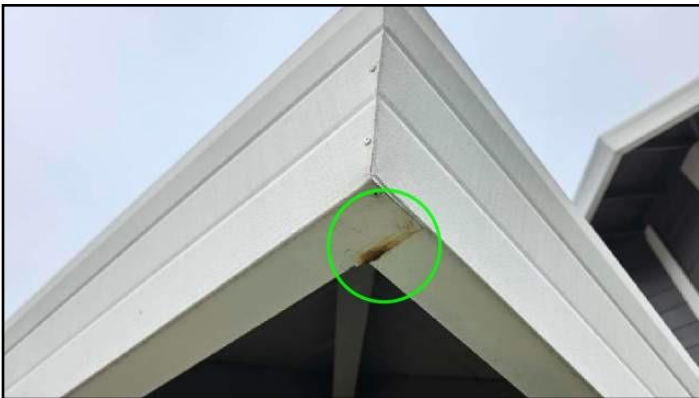
Condition: • Signs of leaking at the gutter and/or downspout seams have been observed.

38. Evidence of gutter leak

Task: Seal gutter and downspout seams with an approved waterproof sealant | Regular maintenance

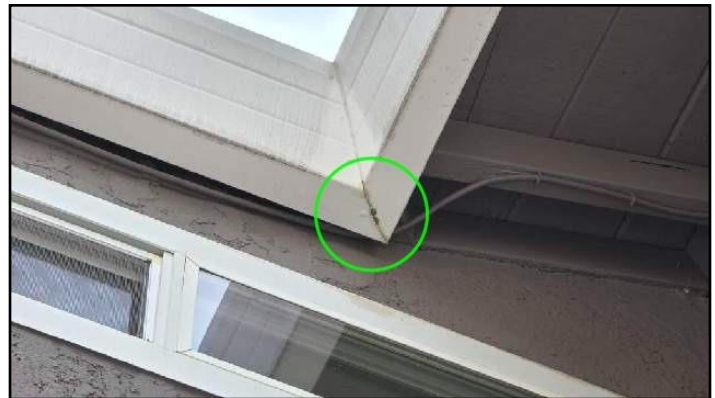
39. Evidence of gutter leak

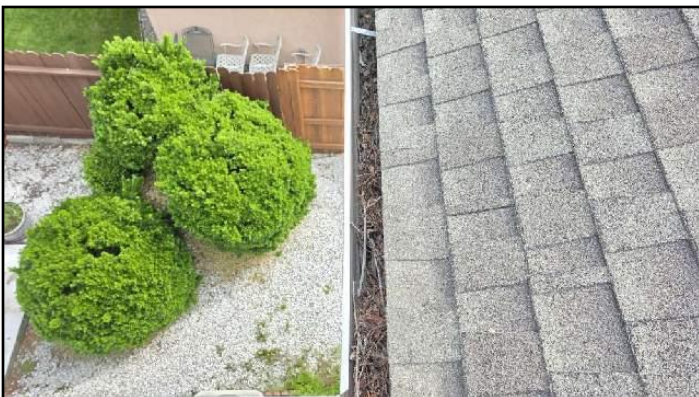
Condition: • Debris was observed in the gutter system during the inspection.

40. Debris in gutter

Task: Corrective service recommended | Regular maintenance

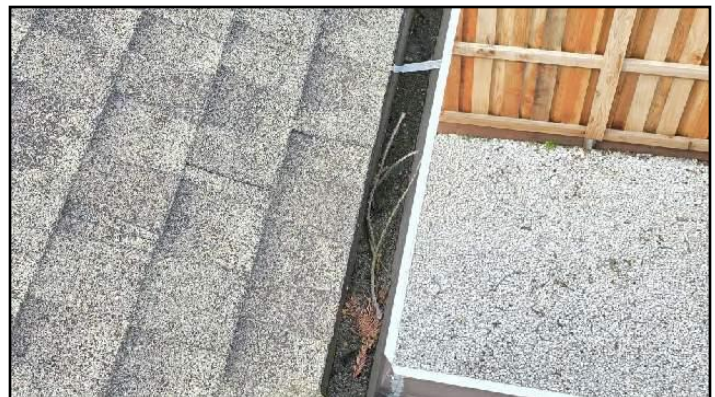
41. Debris in gutter

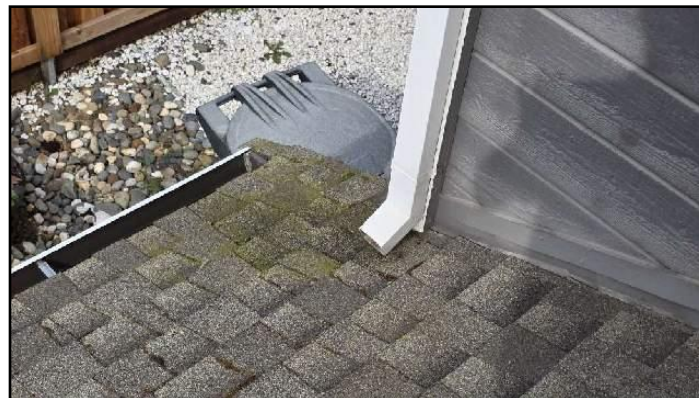
Condition: • Discharge onto roofs

42. Downspout discharges onto roof

Task: Corrective service recommended

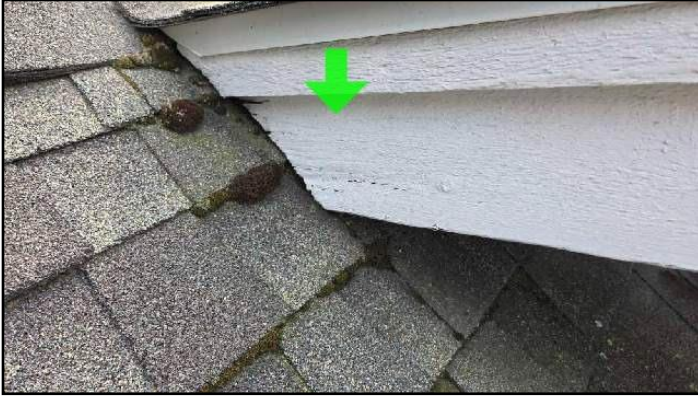
43. Upper level side yard eave

Condition: • Moisture damage noted at the roof eave wood members.

Task: Corrective service recommended | Review repair or replacement estimates by a qualified trade professional

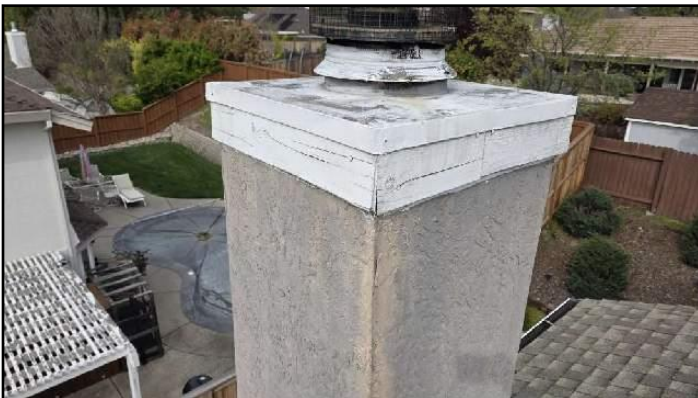
45. Moisture damaged chimney trim boards

Task: Corrective service recommended | Review repair or replacement estimates by a qualified trade professional

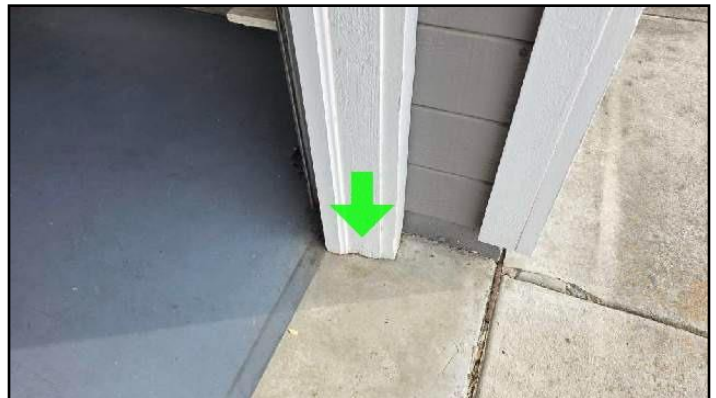
- Moisture damage noted at the base of the vehicle door frame.

46. Moisture damaged vehicle door frame

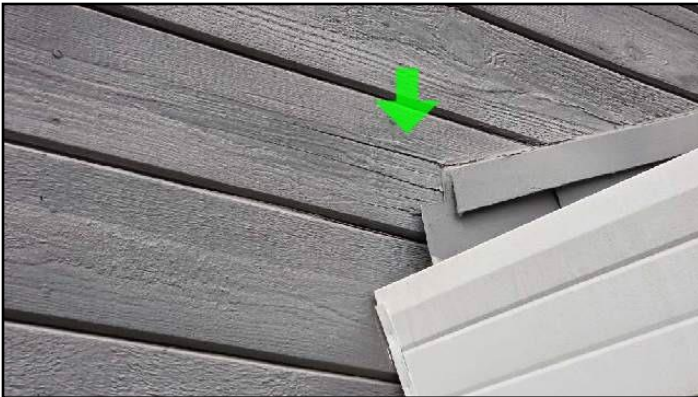
47. Moisture damaged wood siding

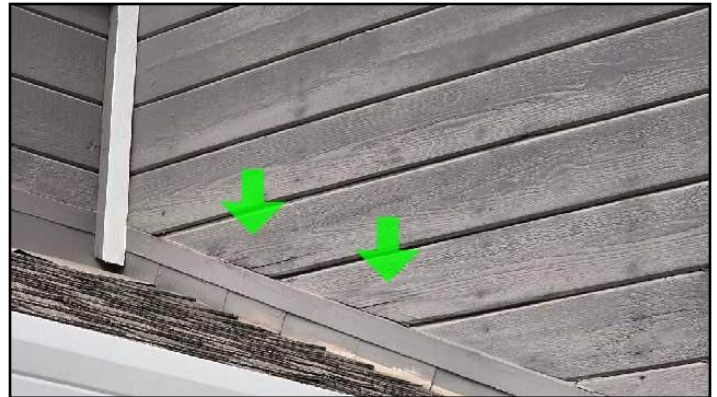
48. Moisture damaged wood siding

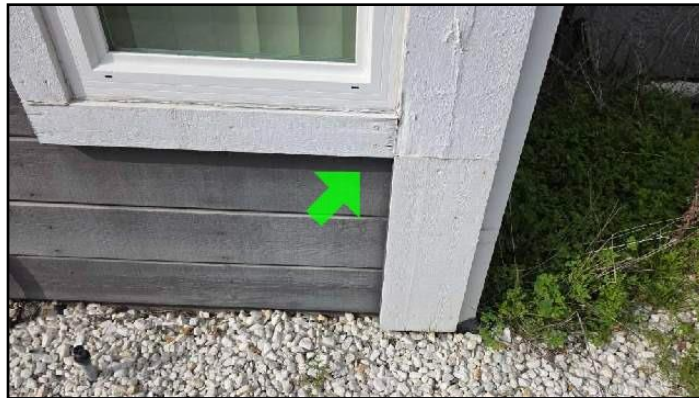
49. Moisture damaged wood siding / trim

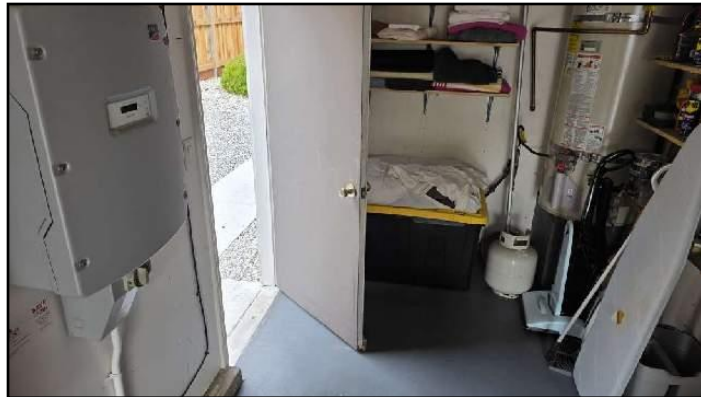
Condition: • The pedestrian door rubs the ground during operation.

50. Pedestrian door rubs the ground

Task: Corrective service recommended

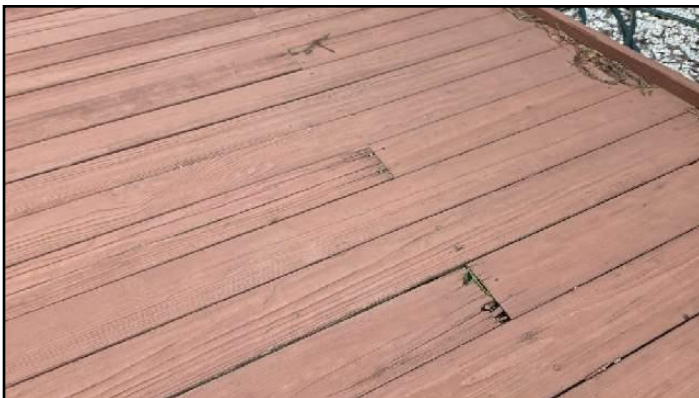
51. Moisture damaged deck boards and framing

Task: Corrective service recommended | Review repair or replacement estimates by a qualified trade professional

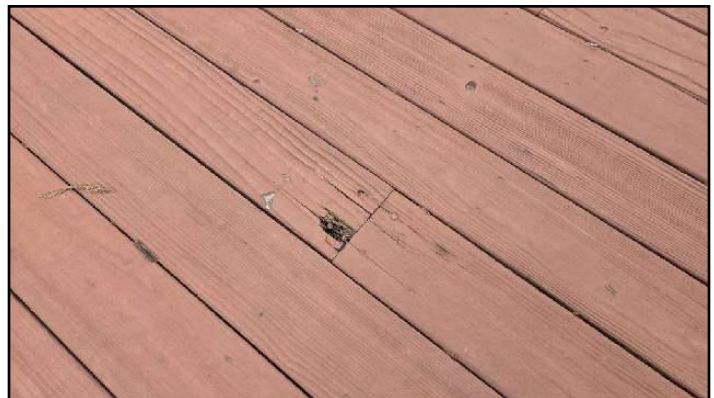
52. Moisture damaged deck boards and framing

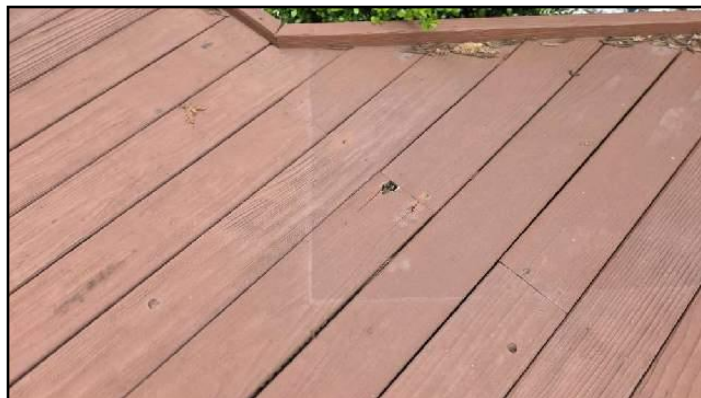
53. Moisture damaged deck boards and framing

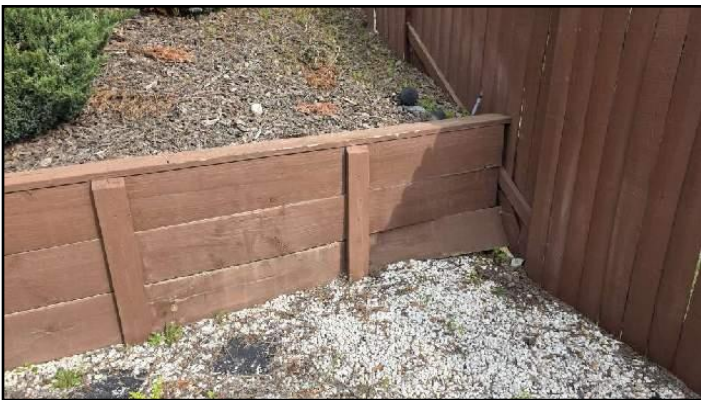
54. Moisture damaged / Leaning retaining wall

Task: Corrective service recommended | Review repair or replacement estimates by a qualified trade professional

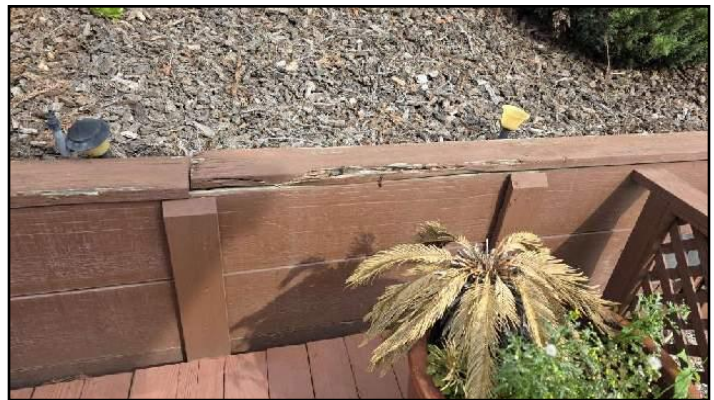
55. Moisture damaged / Leaning retaining wall

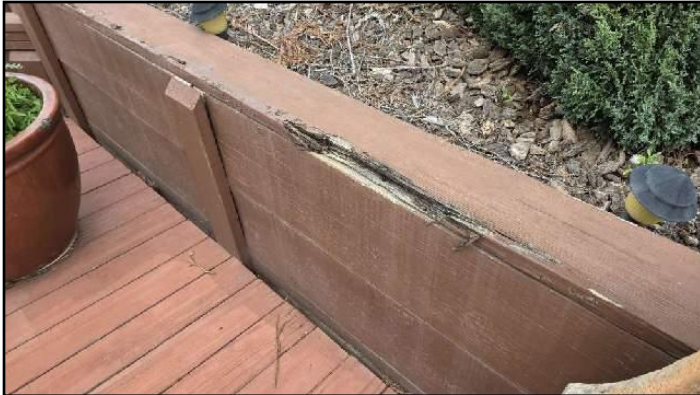
56. Moisture damaged / Leaning retaining wall

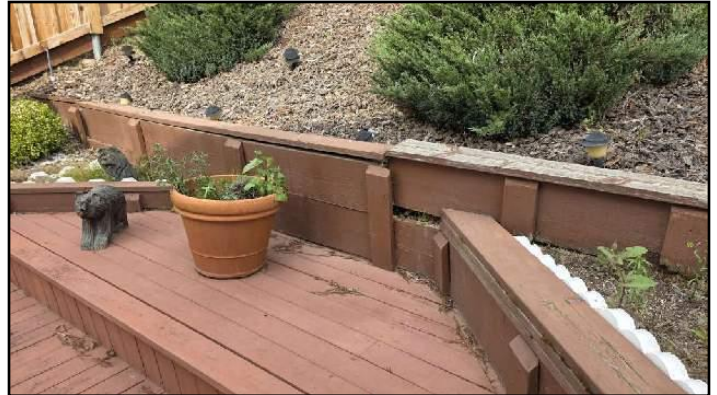
57. Moisture damaged / Leaning retaining wall

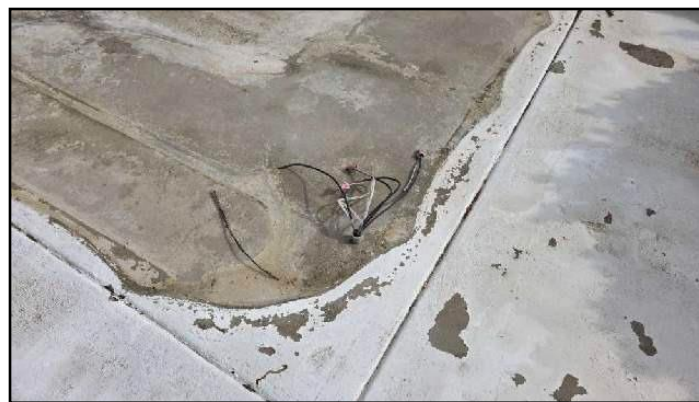
70. Wire ends not contained in a junction box

Task: Electrical repair recommended | Safety Upgrade Recommended

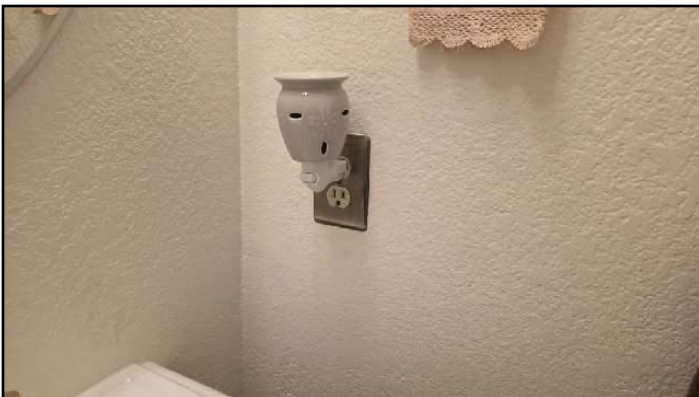
71. Outlet not GFCI protected

Task: Electrical repair recommended | Review repair or replacement estimates by a licensed electrician | Safety upgrade

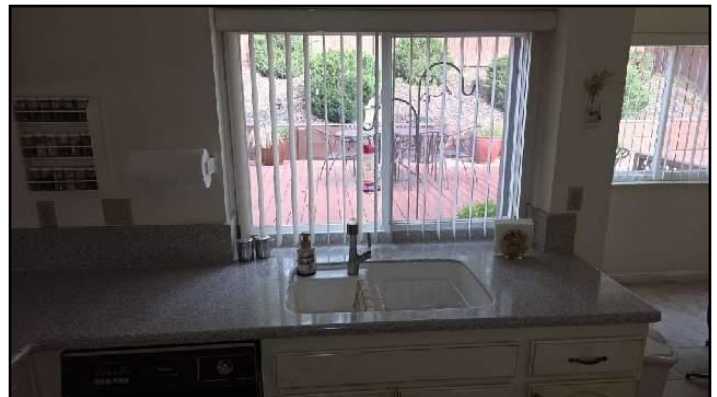
72. Outlets not GFCI protected

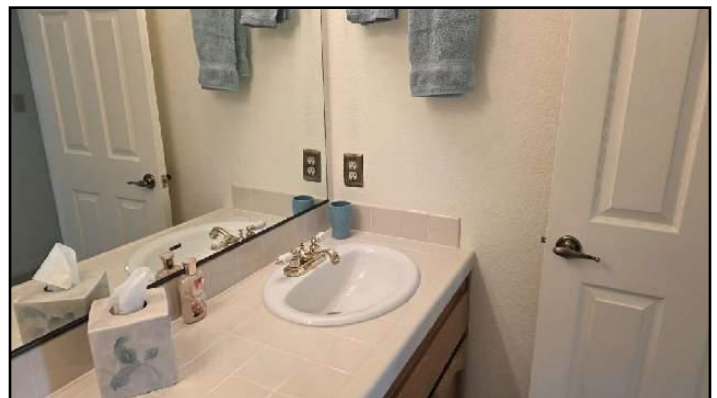
74. Outlet not GFCI protected

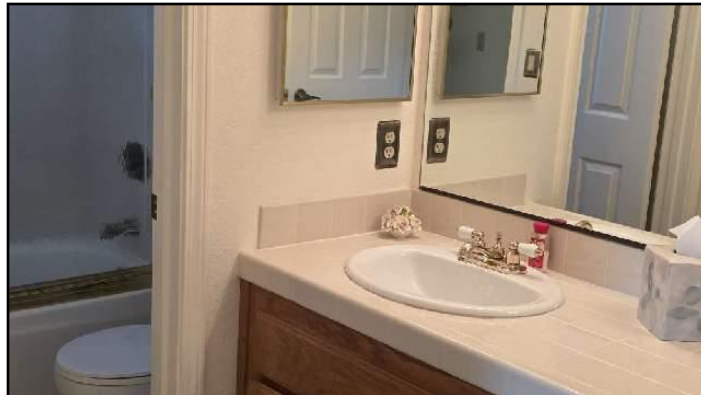
75. Outlet not GFCI protected

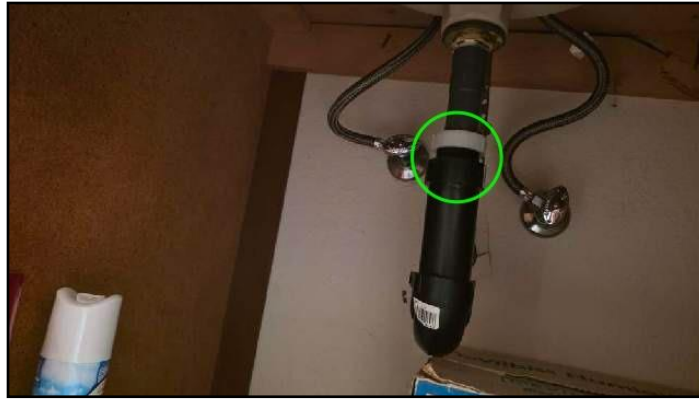
- Leak noted at the sink drain line.

97. *Leak at sink drain line*

Task: Plumbing Repair Recommended | Review repair estimates by a qualified trade professional

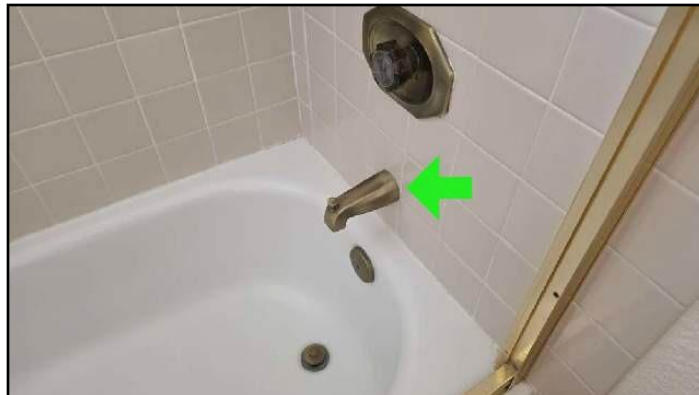
98. *Deteriorated tub spout sealant*

Task: Seal with an approved waterproof sealant | Regular maintenance

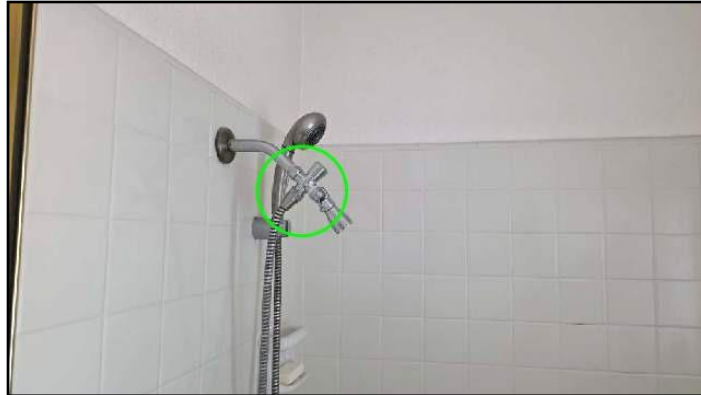
Condition: • The shower head assembly leaks.

100. Shower head assembly leaks

Task: Plumbing Repair Recommended | Review repair estimates by a qualified trade professional

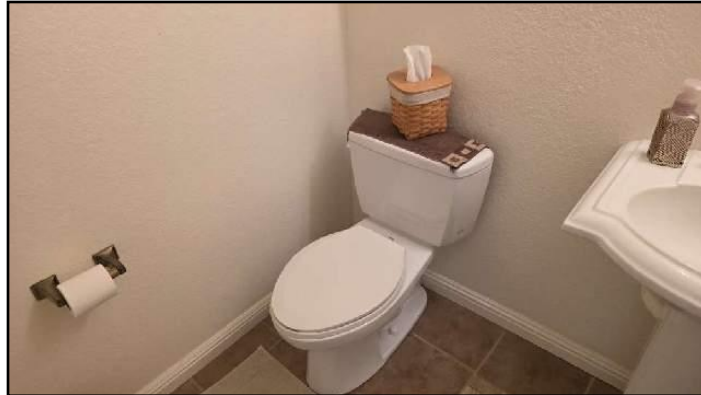
101. *Loose toilet*

Task: Plumbing repair recommended | Review repair or replacement estimates by a qualified trade professional

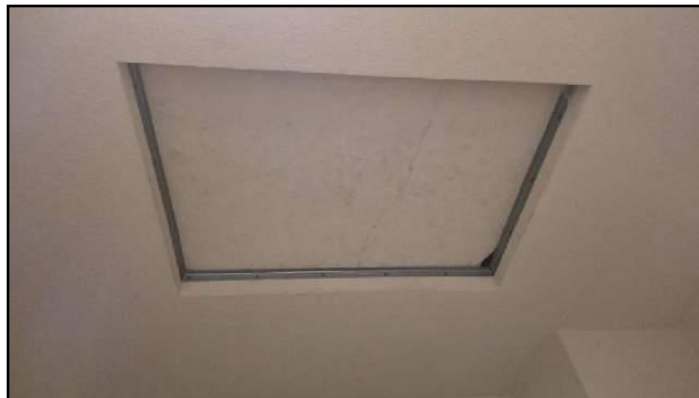
Condition: • Damaged attic access cover noted.

114. *Damaged attic access cover*

Task: Corrective service recommended | Safety Upgrade

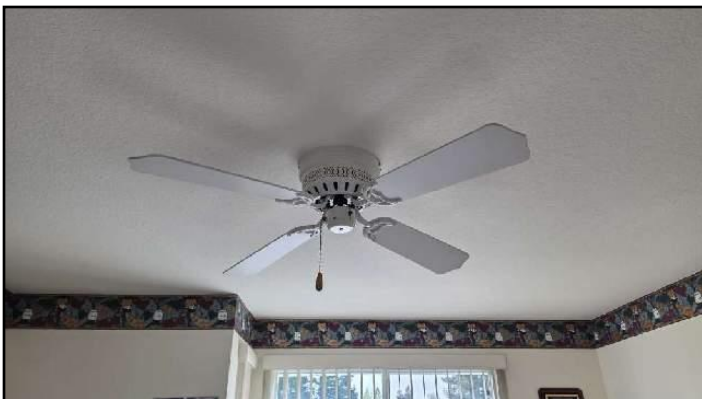
Condition: • The ceiling fan is out of balance. - Ceiling fans are operated at high speed to determine proper balancing.

115. Fan out of balance

Task: Corrective service recommended | Safety Upgrade

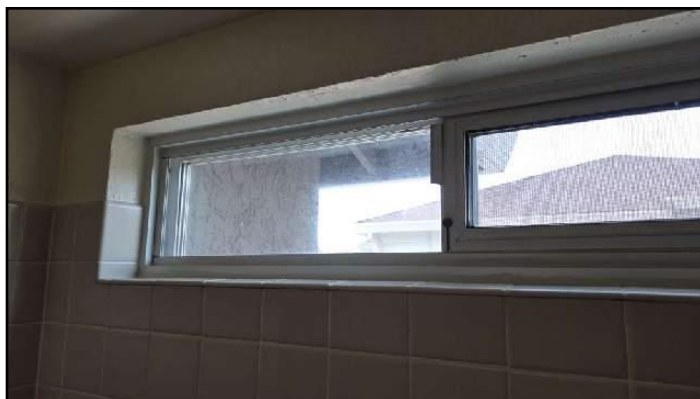
117. Failed window seal

Task: Corrective service recommended | Review repair or replacement estimates by a qualified trade professional

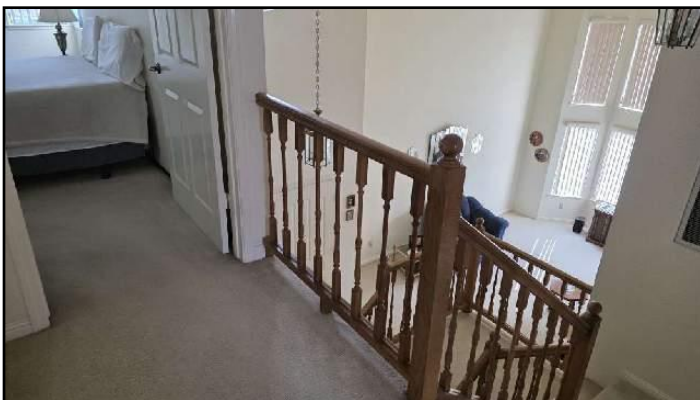
118. Guardrail lower than current standards

Task: Corrective service recommended | Safety Upgrade

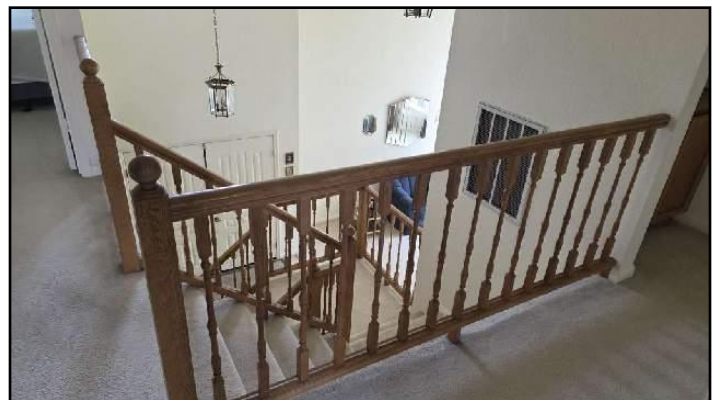
119. Guardrail lower than current standards

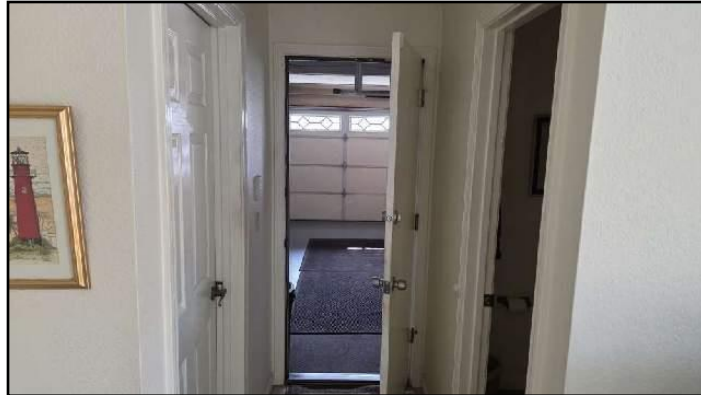
Condition: • The pedestrian door from the garage to the interior is not self-closing.

121. Fire door not self closing

Task: Corrective service recommended | Safety upgrade

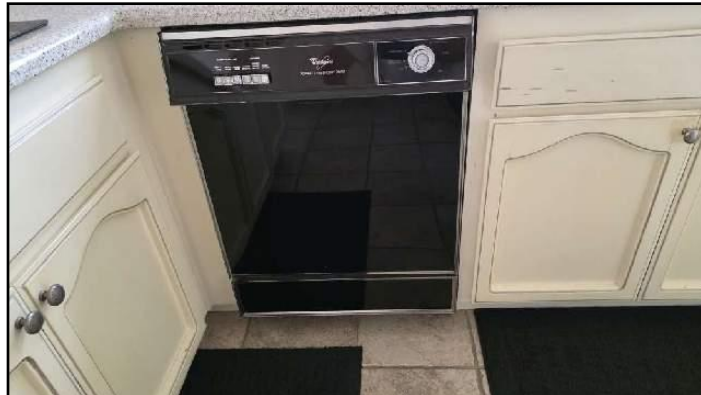
Condition: • The dishwasher is not equipped with an air gap at the kitchen sink. If the drain line from the dishwasher to the waste disposal clogs, waste water will back-up into the dishwasher and potentially leak into the interior of the residence.

Condition: • Backflow prevention high loop missing

122. Dishwasher missing air gap and high loop

Task: Corrective service recommended | Review repair estimates by a qualified trade professional
