Your Inspection Report

Sample Report
My Village, CA

INSPECTION DATE:
Saturday, March 29, 2025

RE: Report No. 1002, v.0
Sample Report
My Village, CA

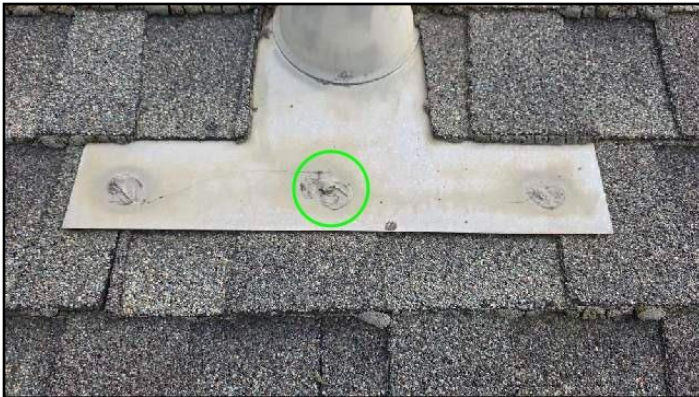
11. Exposed / unsealed fastener

Task: Corrective service recommended | Review repair or replacement estimates by a qualified trade professional

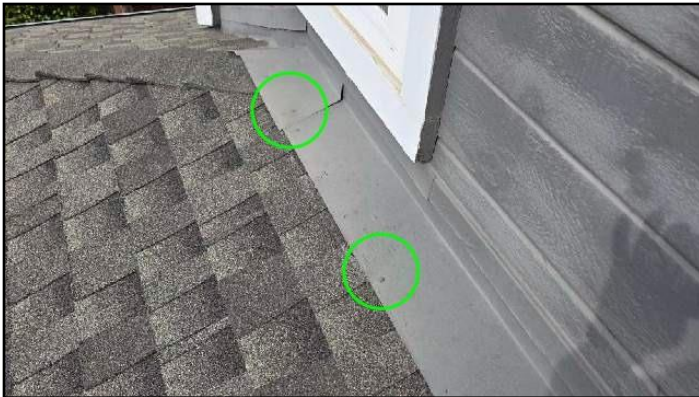
17. Exposed / unsealed fasteners

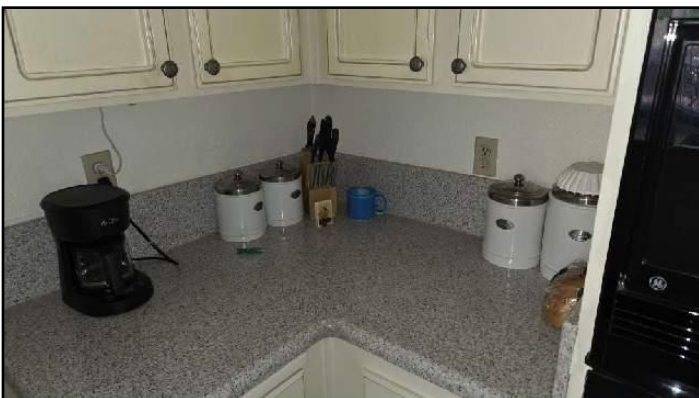
73. Outlets not GFCI protected

Task: Electrical repair recommended | Review repair or replacement estimates by a licensed electrician | Safety upgrade

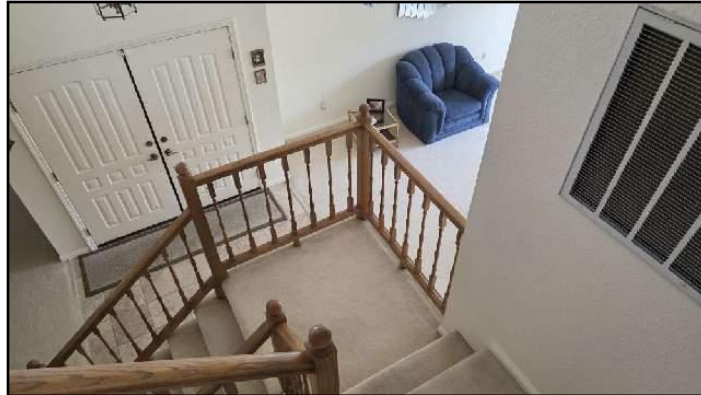
47. Condition: • [Too low](#)

Implication(s): Fall hazard

120. Guardrail lower than current standards

Task: Corrective service recommended | Safety Upgrade
