Your Inspection Report

Sample Report
My Village, CA

INSPECTION DATE:
Saturday, March 29, 2025

RE: Report No. 1002, v.0
Sample Report
My Village, CA

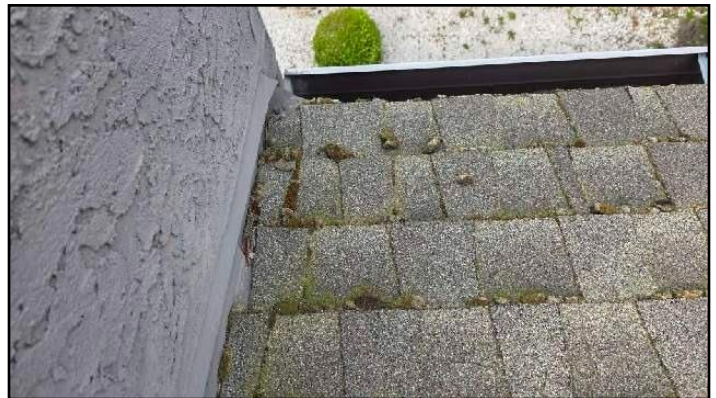
10. Moss growth

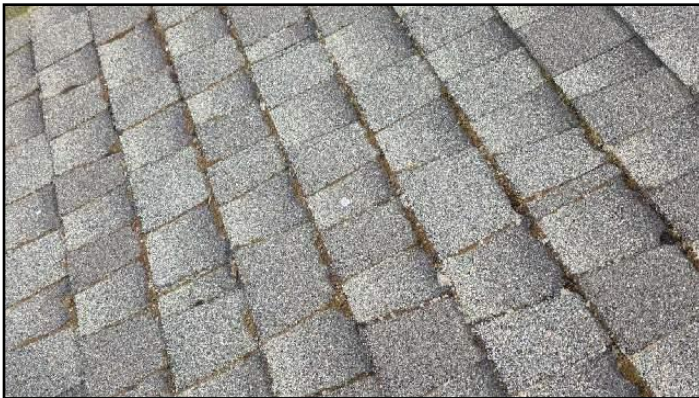
19. Moss growth

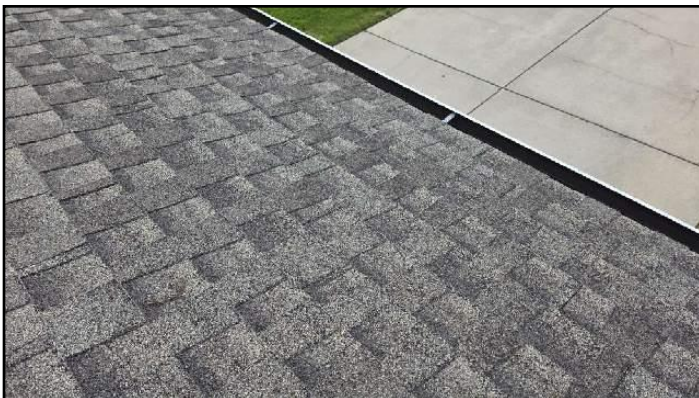
21. Granule loss

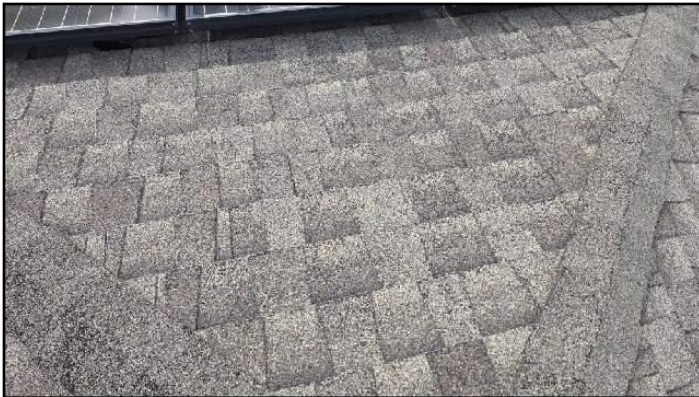
23. Granule loss

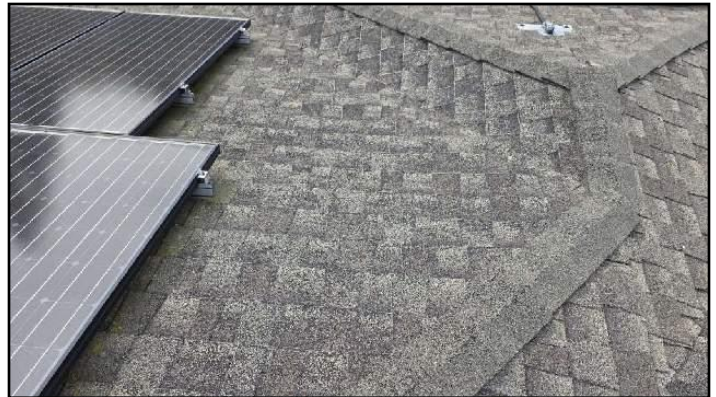
24. Granule loss

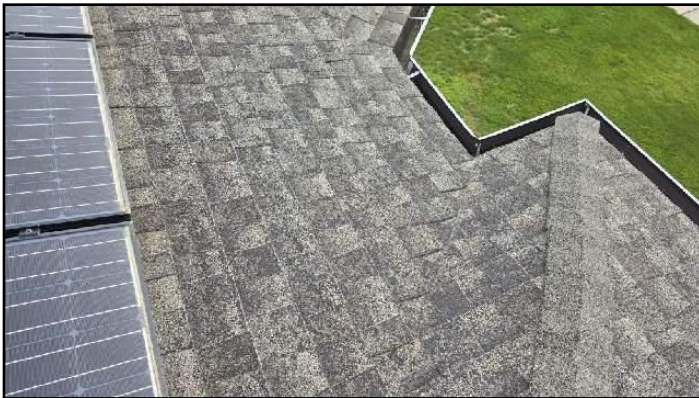
25. Granule loss

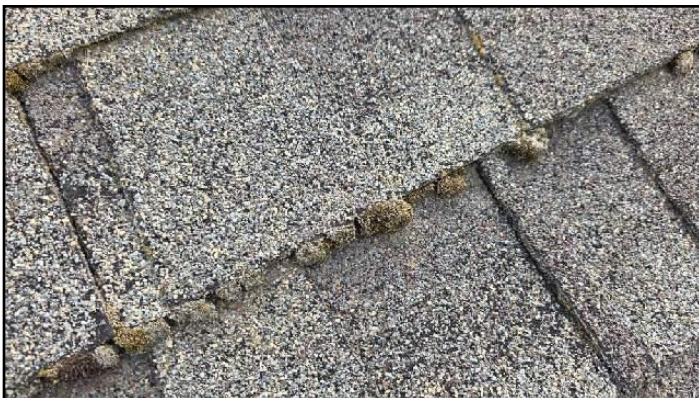
27. Moss growth

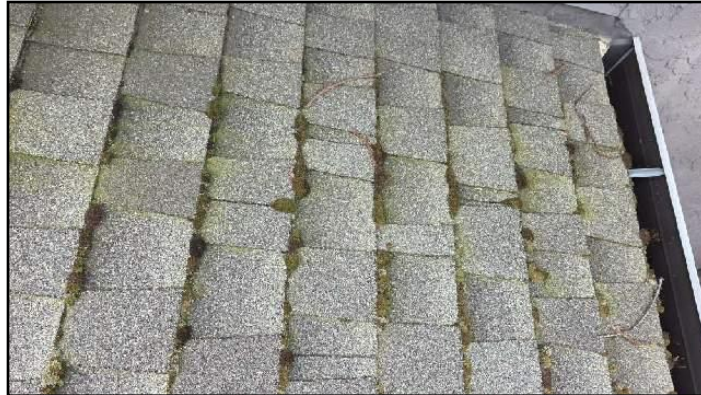
29. *Moss growth*

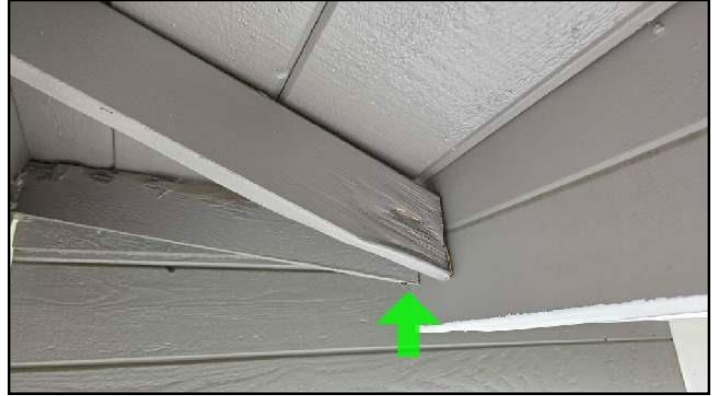
Condition: • Moisture damage noted at the roof eave wood members.

Implication(s): Deterioration of finished materials / Weaken structure

44. Front upper level eave

Task: Corrective service recommended | Review repair or replacement estimates by a qualified trade professional

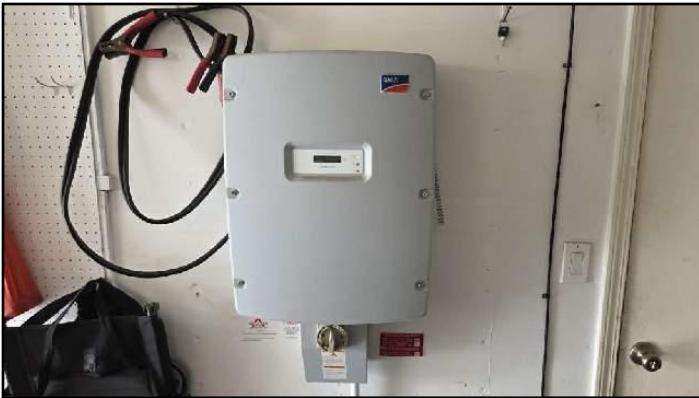
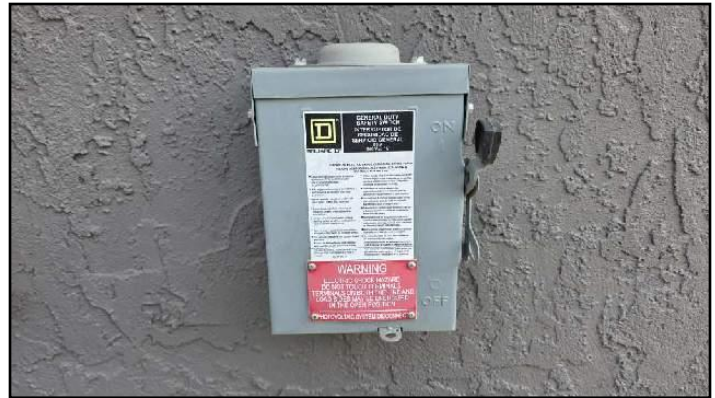
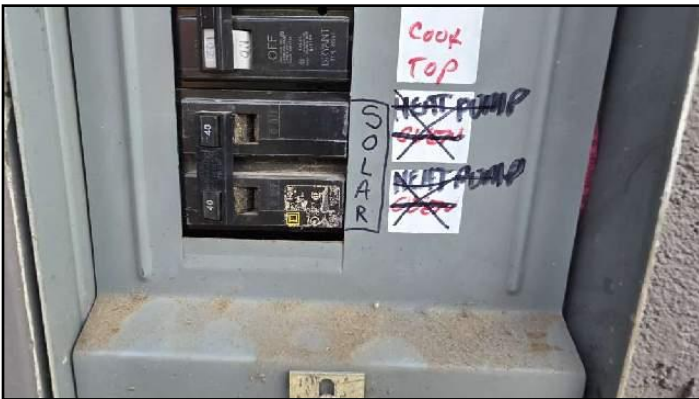
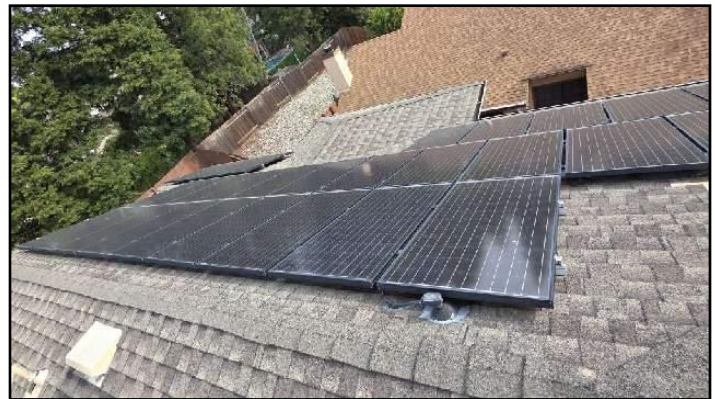
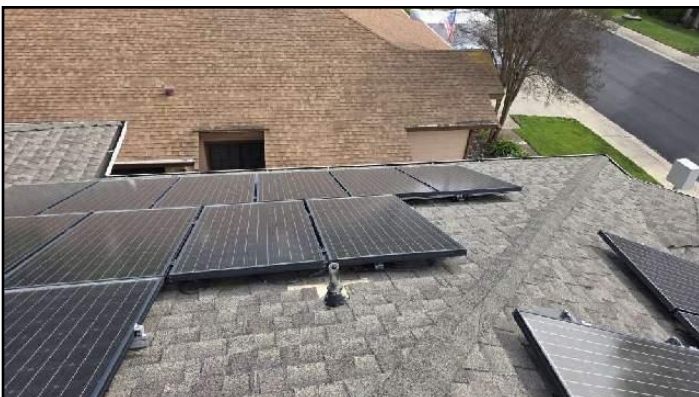
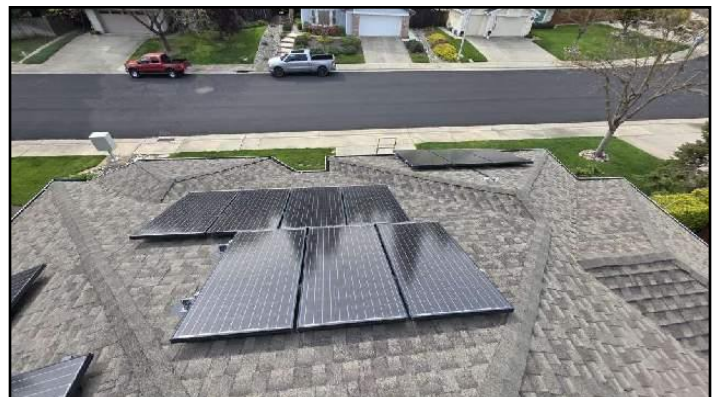
17. Condition: • This home is equipped with a solar electric generation system which is beyond the scope of work for this inspection. You should obtain all documents concerning this equipment from the seller prior to final purchase

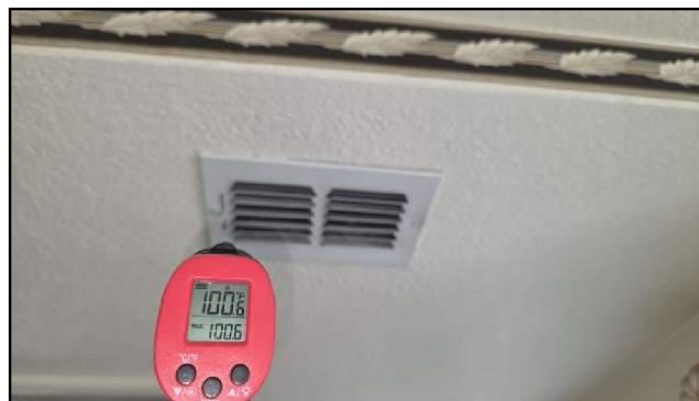
82.

24. Condition: • The heating systems functioned as expected when activated through standard controls, unless specified otherwise below.

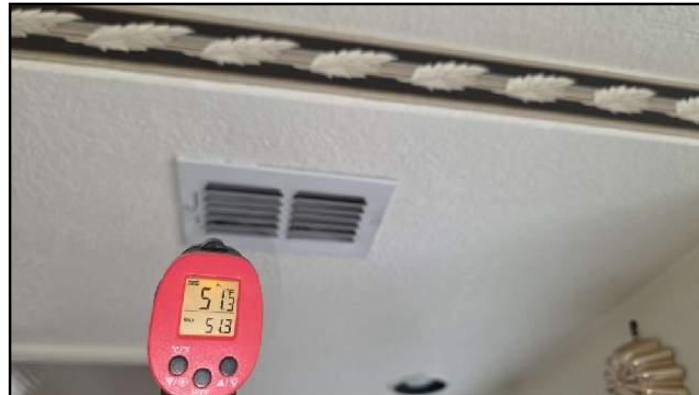
85.

29. Condition: • The air conditioner(s) operated when tested by using normal controls, unless otherwise noted below.

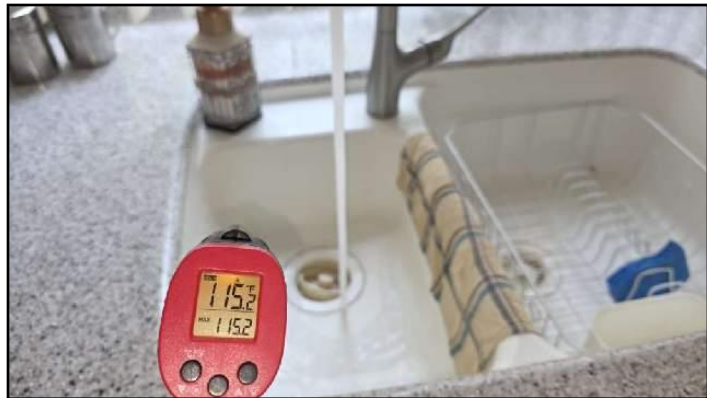
96.

32. Condition: • Water heating system operated when tested

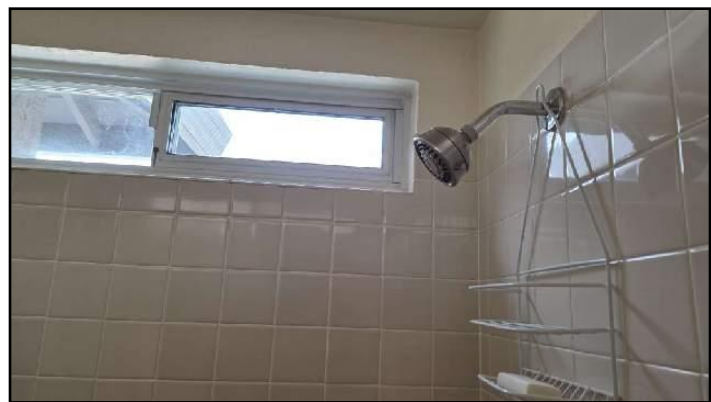
99.

Location: 2nd floor hallway bathroom

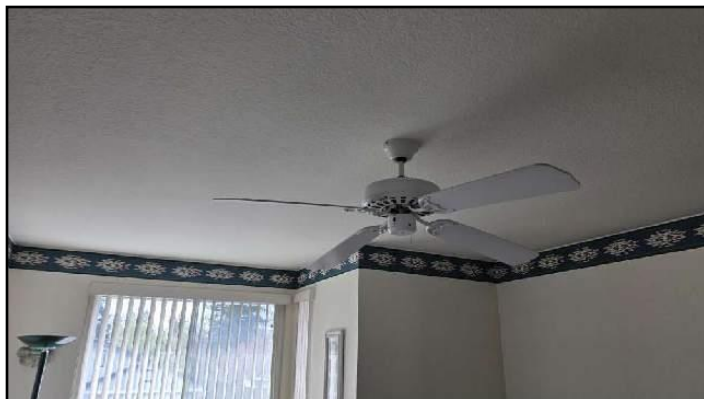
45. Condition: • The ceiling fan is out of balance. - Ceiling fans are operated at high speed to determine proper balancing.

Implication(s): Damage to equipment / Physical injury due to falling materials

116. Fan out of balance

Task: Corrective service recommended | Safety Upgrade
